## H-AC Projekt s.r.o.

# Termografická skúška podľa STN EN 13187 - zjednodušená

## *Protokol č.*

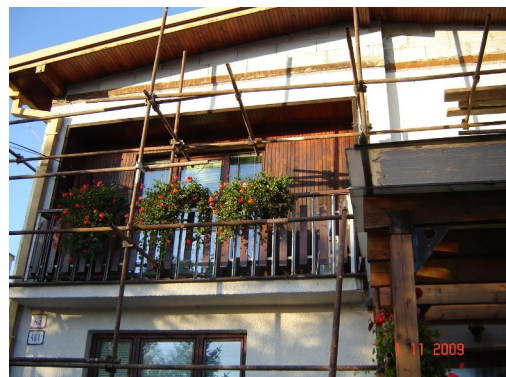
## Východná stena, poschodie

## Main Image Markers

| Name | Temperature | Emissivity | Background |
|---|---|---|---|
| P0 | -0.7°C | 0.93 | 1.0°C |
| P1 | -4.4°C | 0.93 | 1.0°C |
| P2 | 3.3°C | 0.93 | 1.0°C |

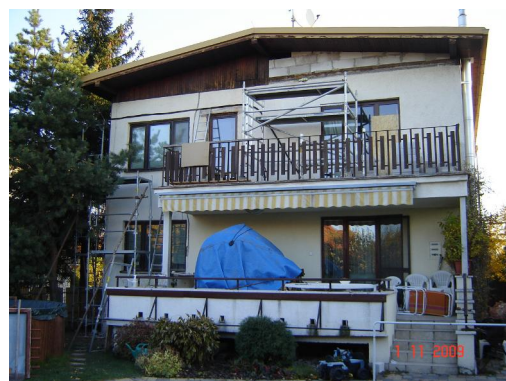
## Západná stena, prízemie, nárožie na juh

### Main Image Markers

| Name | Temperature | Emissivity | Background |
|---|---|---|---|
| P0 | 1.9°C | 0.93 | 1.0°C |
| P1 | -1.7°C | 0.93 | 1.0°C |
| P2 | 3.2°C | 0.93 | 1.0°C |
| P3 | -0.6°C | 0.93 | 1.0°C |

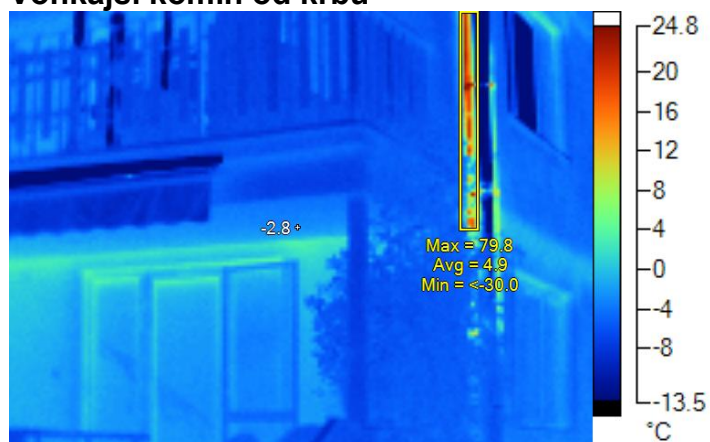
## Vonkajší komín od krbu

### Main Image Markers

| Name | Avg | Min | Max | Emissivity | Background | St. Dev. |
|---|---|---|---|---|---|---|
| A0 | 4.9°C | <-30.0°C | 79.8°C | 0.25 | 1.0°C | 38.77 |
| Středový bod | -2.8°C | | | 0.93 | 1.0°C | |

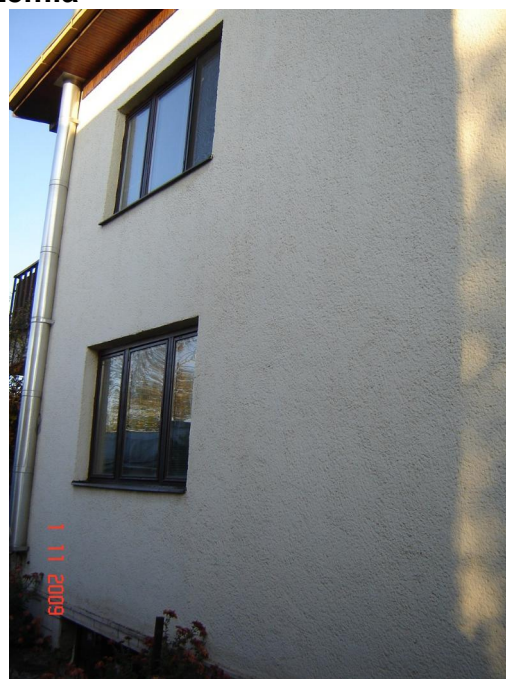
## Južná stena, nadokenný preklad nad oknom prízemia

### Main Image Markers

| Name | Temperature | Emissivity | Background |
|---|---|---|---|
| Středový bod | 2.2°C | 0.93 | 1.0°C |
| P0 | 3.1°C | 0.93 | 1.0°C |
| P1 | 0.1°C | 0.93 | 1.0°C |
| P2 | -4.6°C | 0.93 | 1.0°C |
| P3 | -0.9°C | 0.93 | 1.0°C |

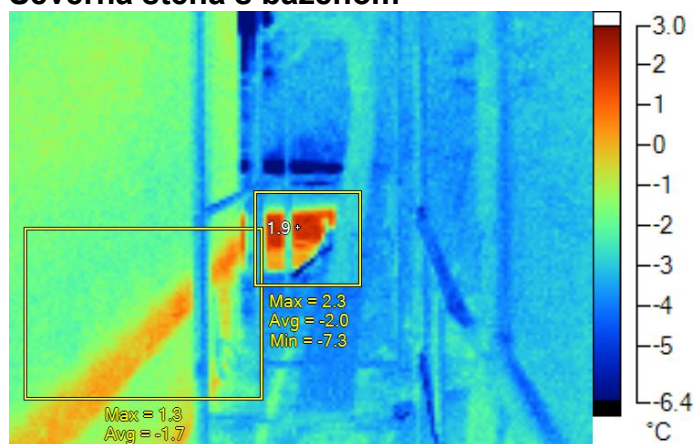
## Severná stena s bazénom

## Main Image Markers

| Name | Avg | Min | Max | Emissivity | Background | St. Dev. |
|---|---|---|---|---|---|---|
| A0 | -1.7°C | -4.3°C | 1.3°C | 0.93 | 1.0°C | 0.94 |
| A1 | -2.0°C | -7.3°C | 2.3°C | 0.93 | 1.0°C | 2.01 |
| Středový bod | 1.9°C | | | 0.93 | 1.0°C | |
